## Roadway Inventory

Sheet: RD-40  
Roadway Inventory

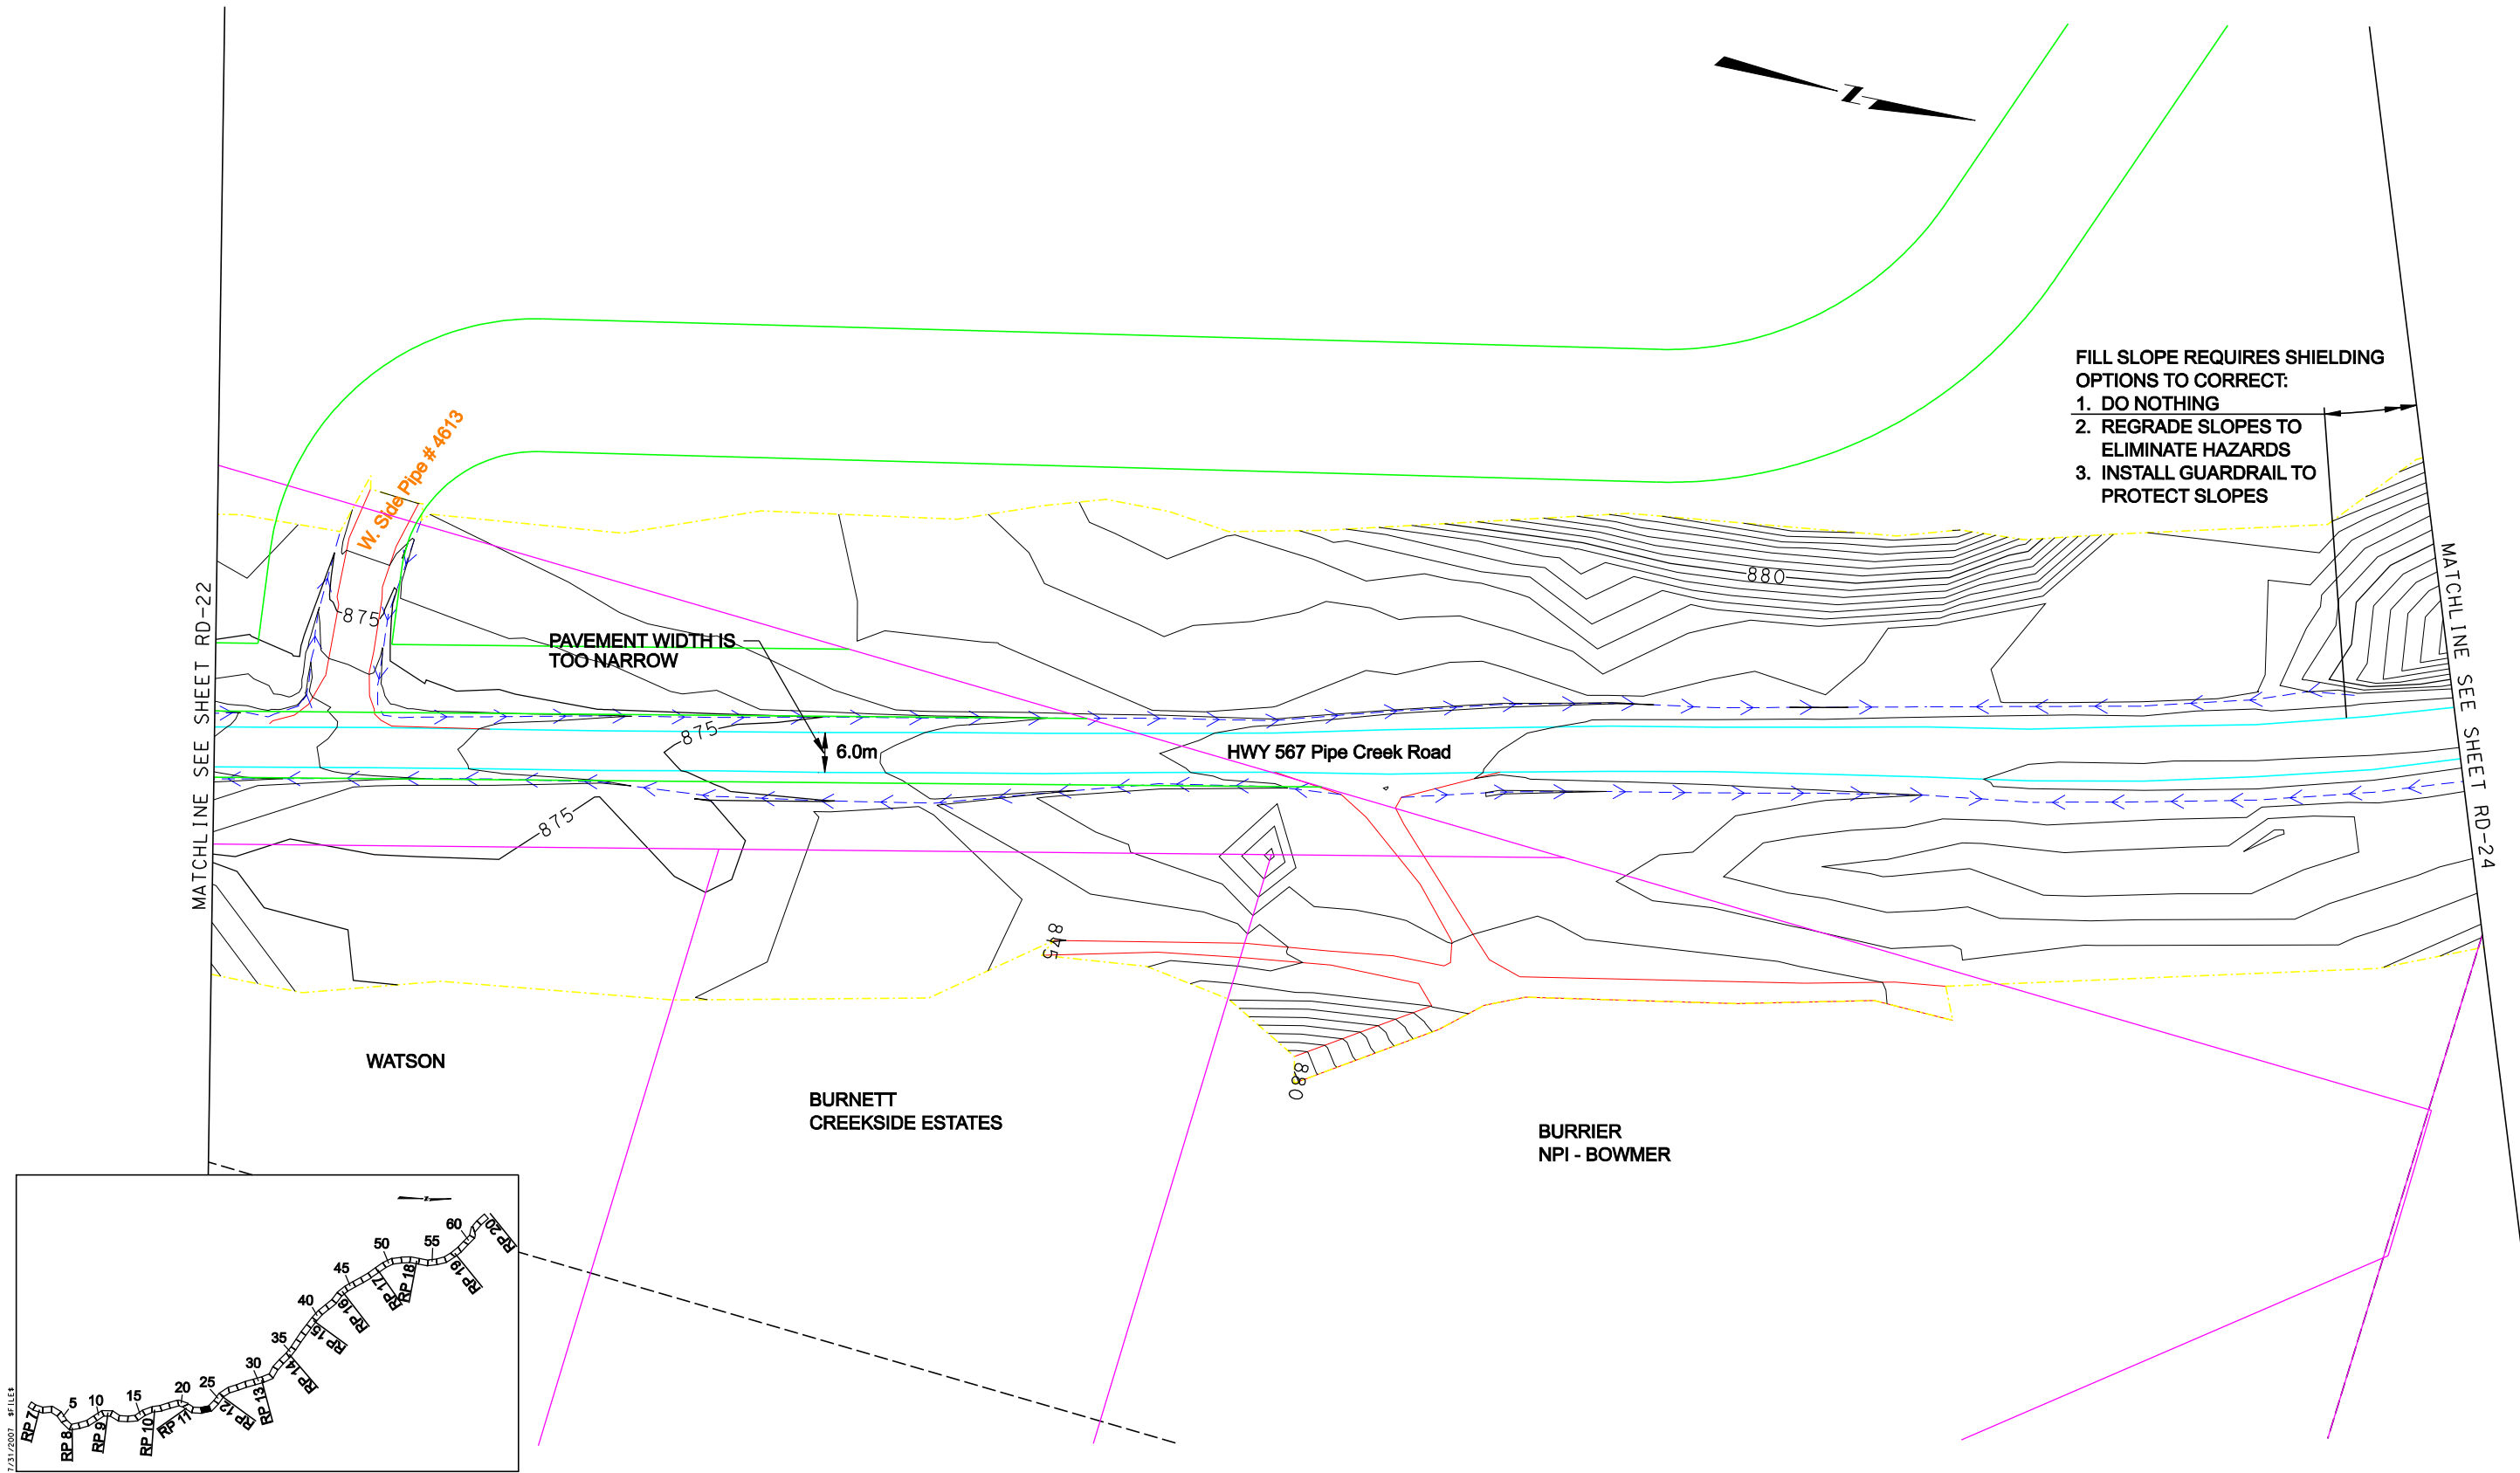
FILL SLOPE REQUIRES SHIELDING  
OPTIONS TO CORRECT:  
1. DO NOTHING  
2. REGRADE SLOPES TO  
ELIMINATE HAZARDS  
3. INSTALL GUARDRAIL TO  
PROTECT SLOPES

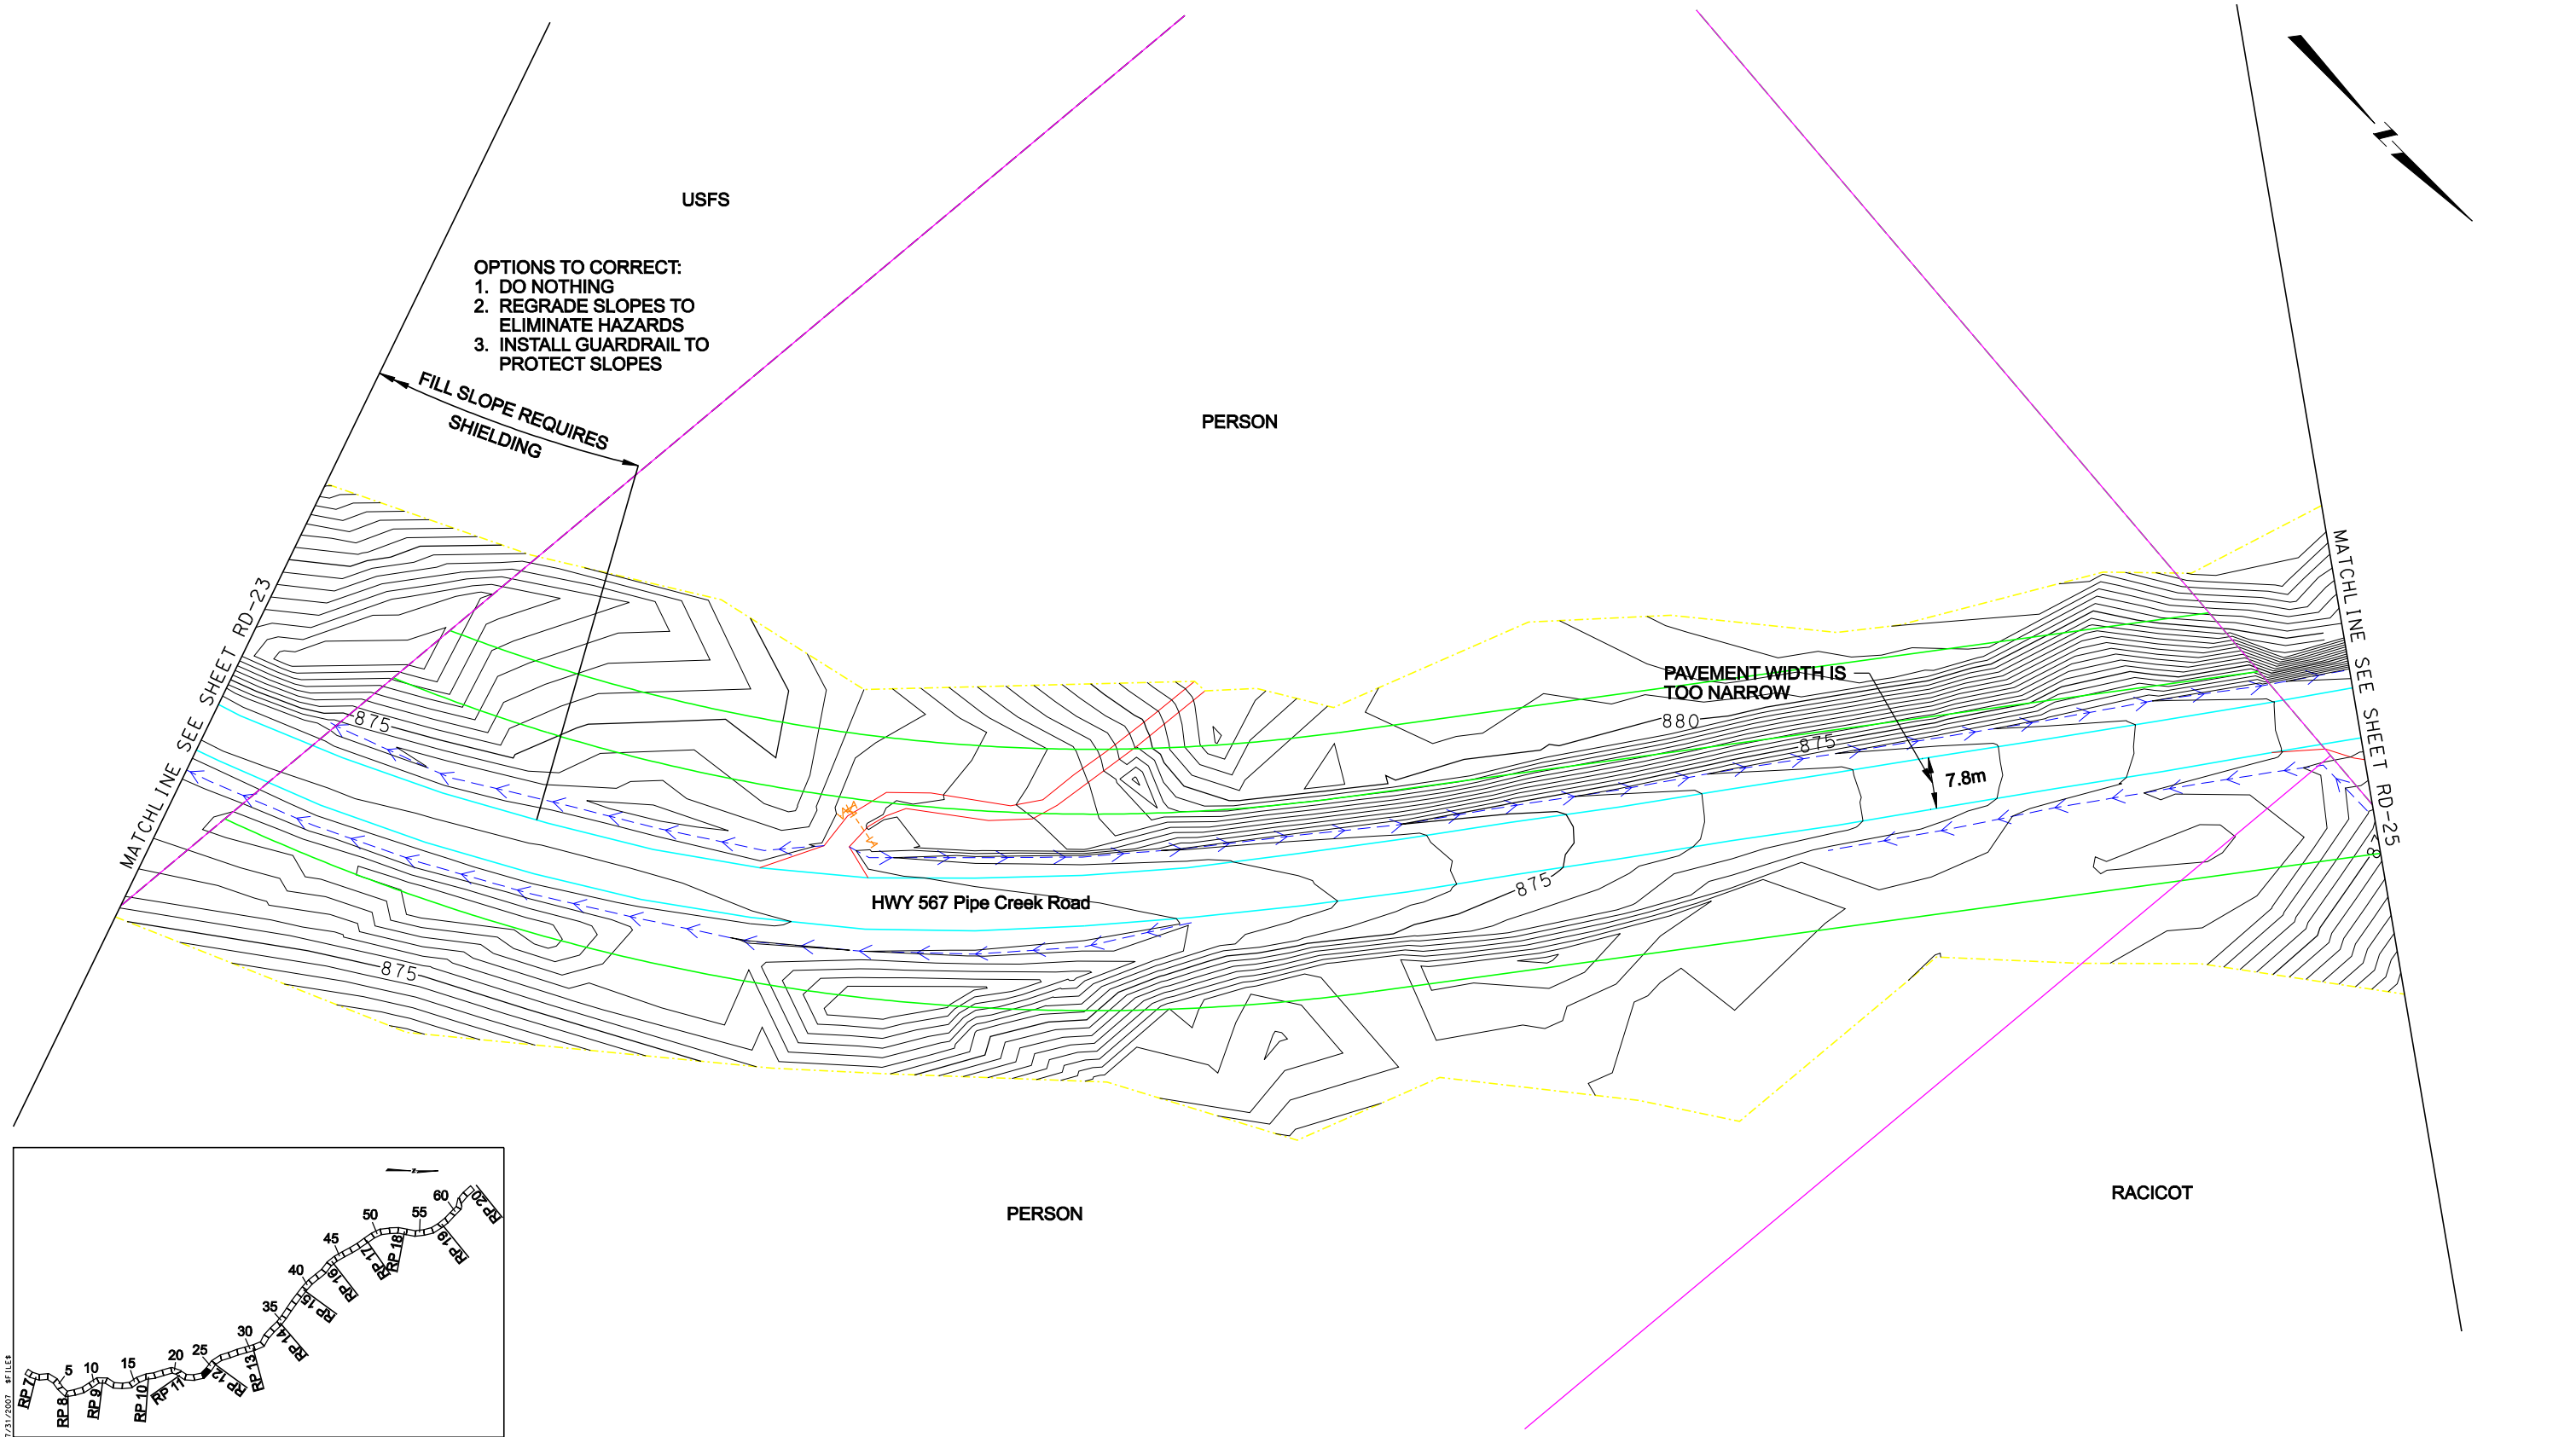
PAVEMENT WIDTH IS  
TOO NARROW

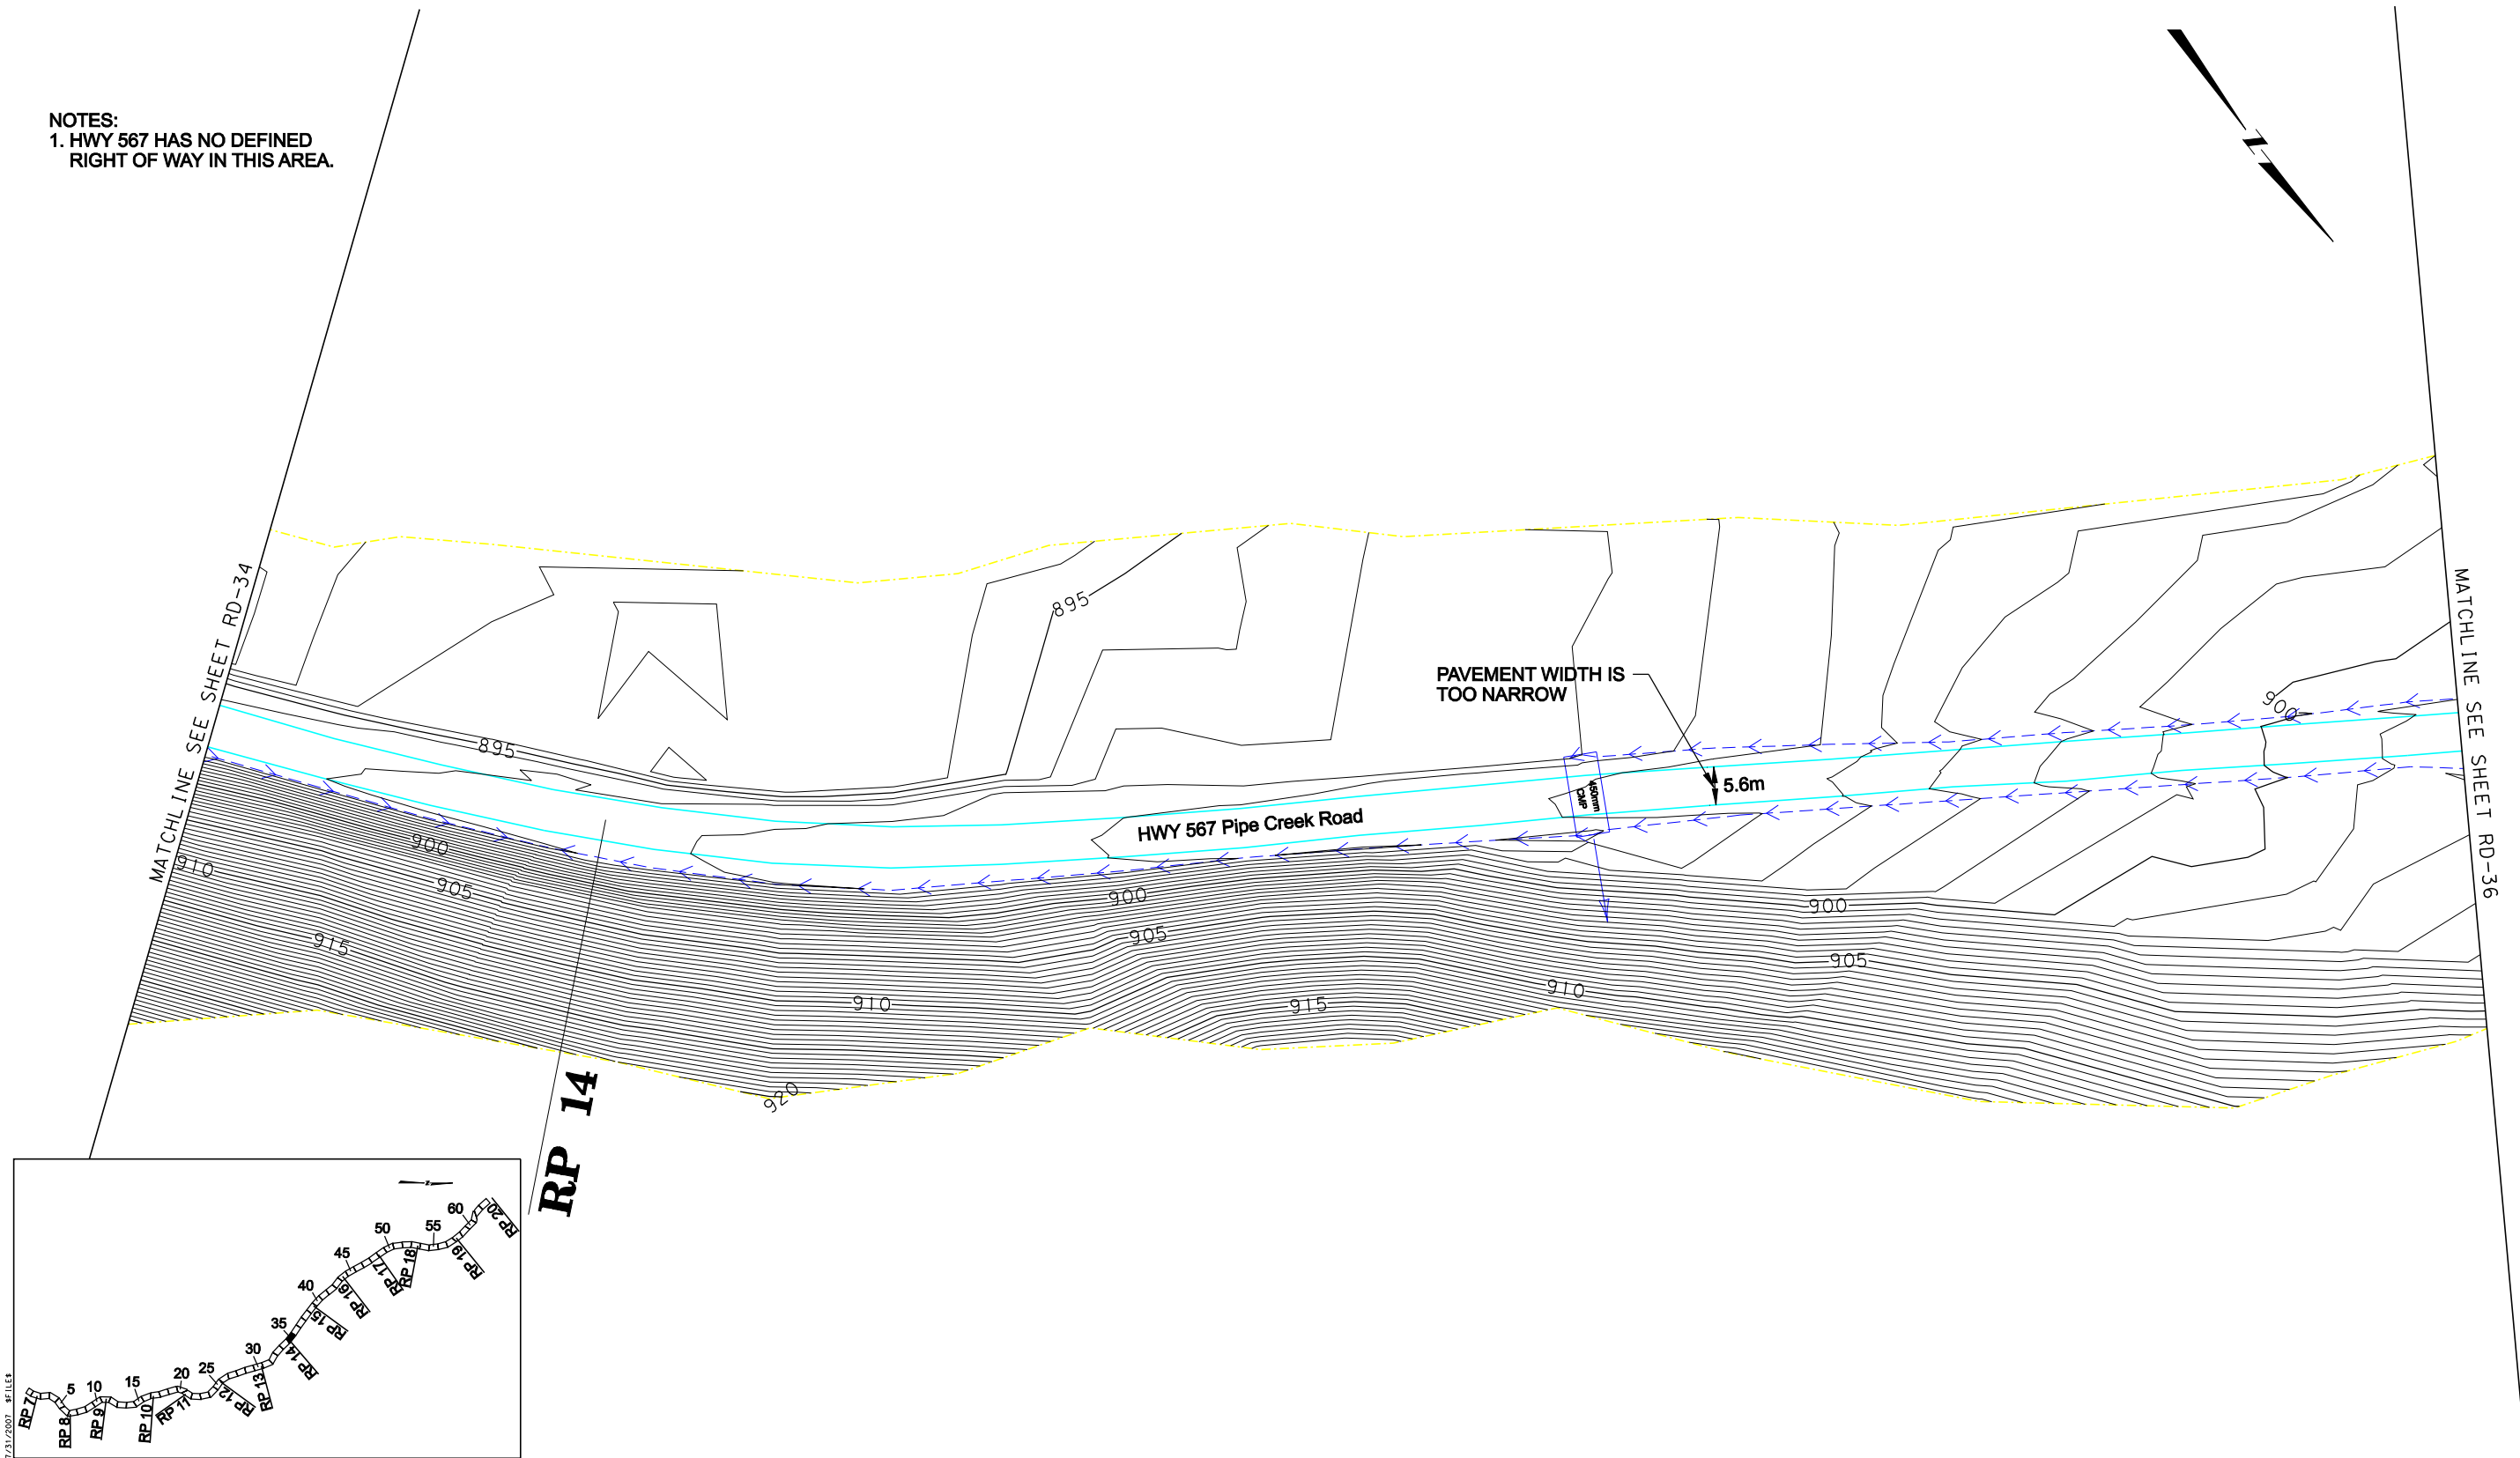
GUARDRAIL LENGTH  
ISN'T ADEQUATE

PAVEMENT WIDTH IS  
TOO NARROW

VPI OF A 35m SAG VERTICAL CURVE  
SSD = 65m  
SSD SHOULD BE = 105m

OPTIONS TO CORRECT:

1. DO NOTHING
2. UPGRADE GUARDRAIL TO CURRENT STANDARDS.

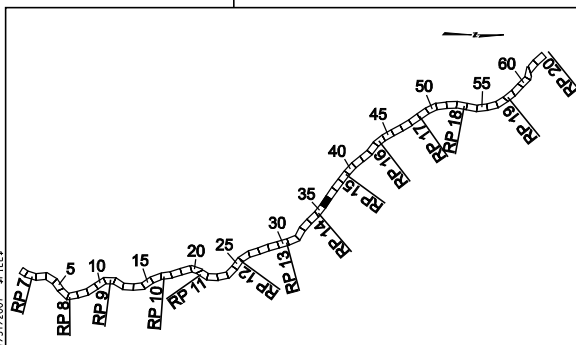
PAVEMENT WIDTH IS  
TOO NARROW

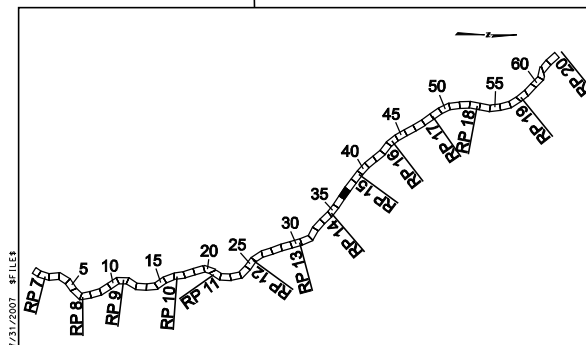
Sheet: RD-37

PAVEMENT WIDTH IS  
TOO NARROW

VPI OF A 35m VERTICAL CURVE  
SSD = 65m  
SSD SHOULD BE = 105m

OPTIONS TO CORRECT SNOW STORAGE PROBLEM:  
1. DO NOTHING  
2. USE ALTERNATIVE SNOW REMOVAL TECHNOLOGY  
(SNOW BLOWER INSTEAD OF PLOW).  
3. RECONSTRUCT ROAD TO ALLOW FOR  
ADEQUATE SNOW STORAGE AREA.

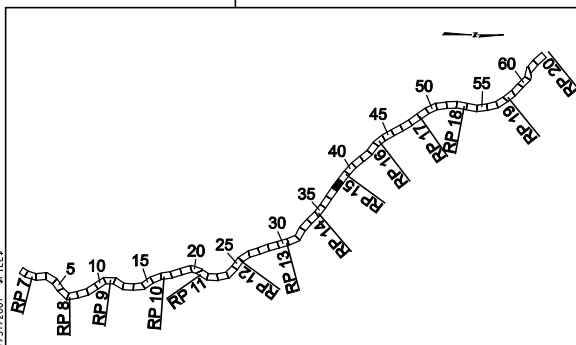
PAVEMENT WIDTH IS  
TOO NARROW
